ELBERT CREEK  
WATER COMPANY

# WATER IN THE WORKS

AN ELBERT CREEK WATER COMPANY QUARTERLY NEWSLETTER  
ISSUE 6/AUGUST 2021

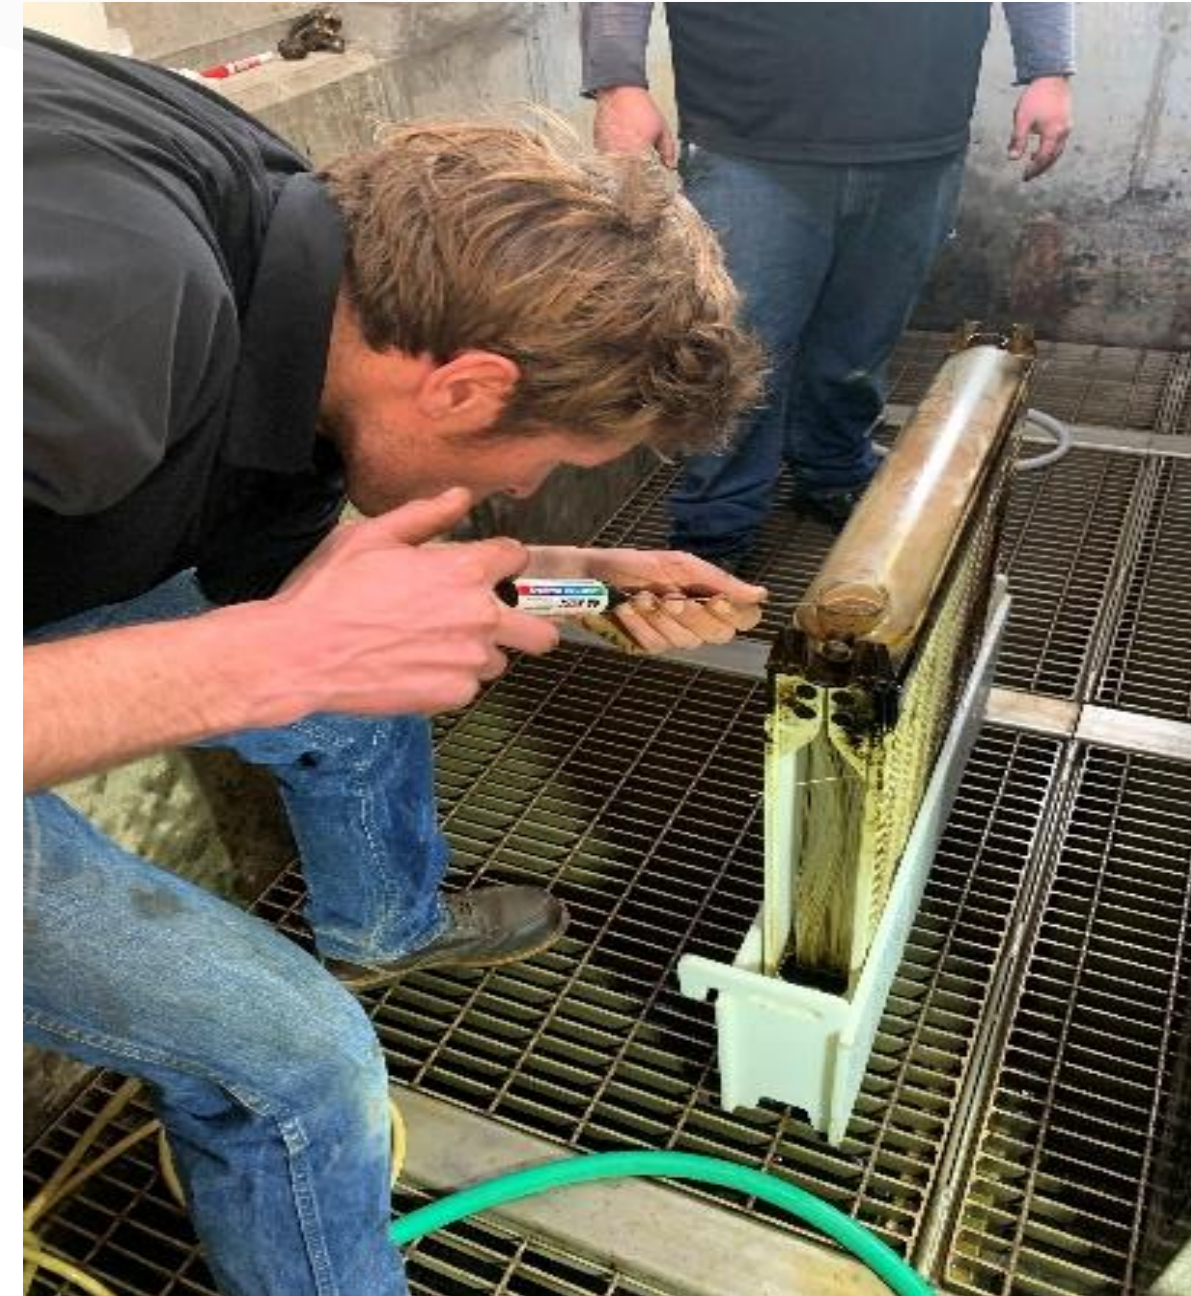
Logan makes membrane repairs right before the start of ECWC's busy season.

Summer is in full swing and ECWC is firing on all cylinders! With additional operators, ECWC has been very proactive with maintenance both at the treatment plants and out in the distribution/collections system. We've spent a lot of time taking an in-depth look at our membrane system. In 2018 the Water Treatment Plant upgraded from a media-based filter to a Microfiltration Membrane filter. To oversimplify, it's like a spaghetti strand with tiny holes that allows the water to pass through and captures any particulates. We can diagnose filter issues through weekly Membrane Integrity Tests (MITs) and visual inspections. If membrane maintenance is required, we pull the membrane train from the filter basin, then remove the cassette from the train. After we clean off the cassette, we apply air to the cassette to see exactly which strands are broken. We then take a long needle applicator and apply the repair material and let dry. We are essentially cauterizing the strands. When the repairs are done, we run another MIT to ensure test pressures are in a passing range.

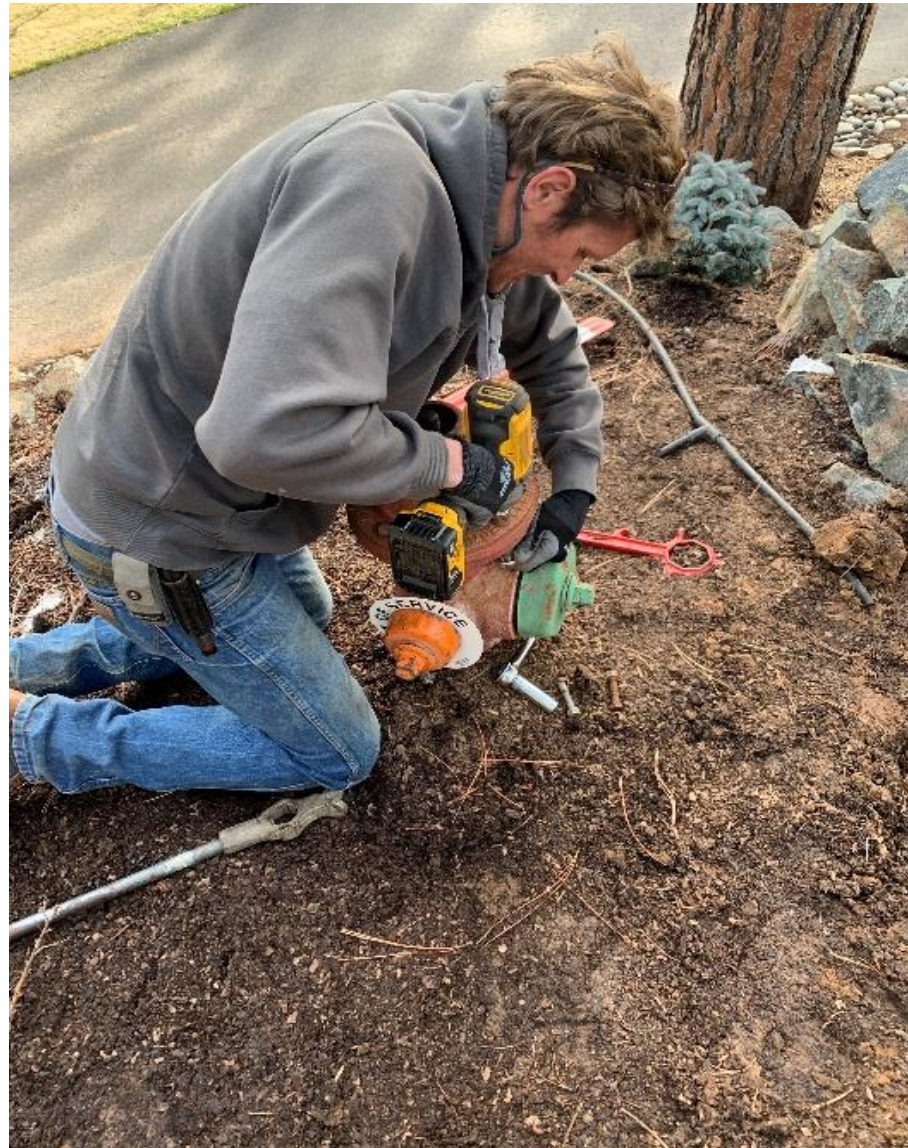
Logan removing a fire hydrant bonnet to access the internal stem, which was removed and replaced.

With the arrival of summer comes a concern we all have: fire safety. The 416 Fire was only a few years ago and it still lingers in a lot of our minds. Here at ECWC, we take fires just as seriously as you. We take a proactive approach with our Hydrant Inspection and Flushing Program. ECWC is also working closely with the Durango Fire Protection District on keeping their records in proper order and satisfying their ISO program. With this routine maintenance, hydrant deficiencies can be identified and addressed.

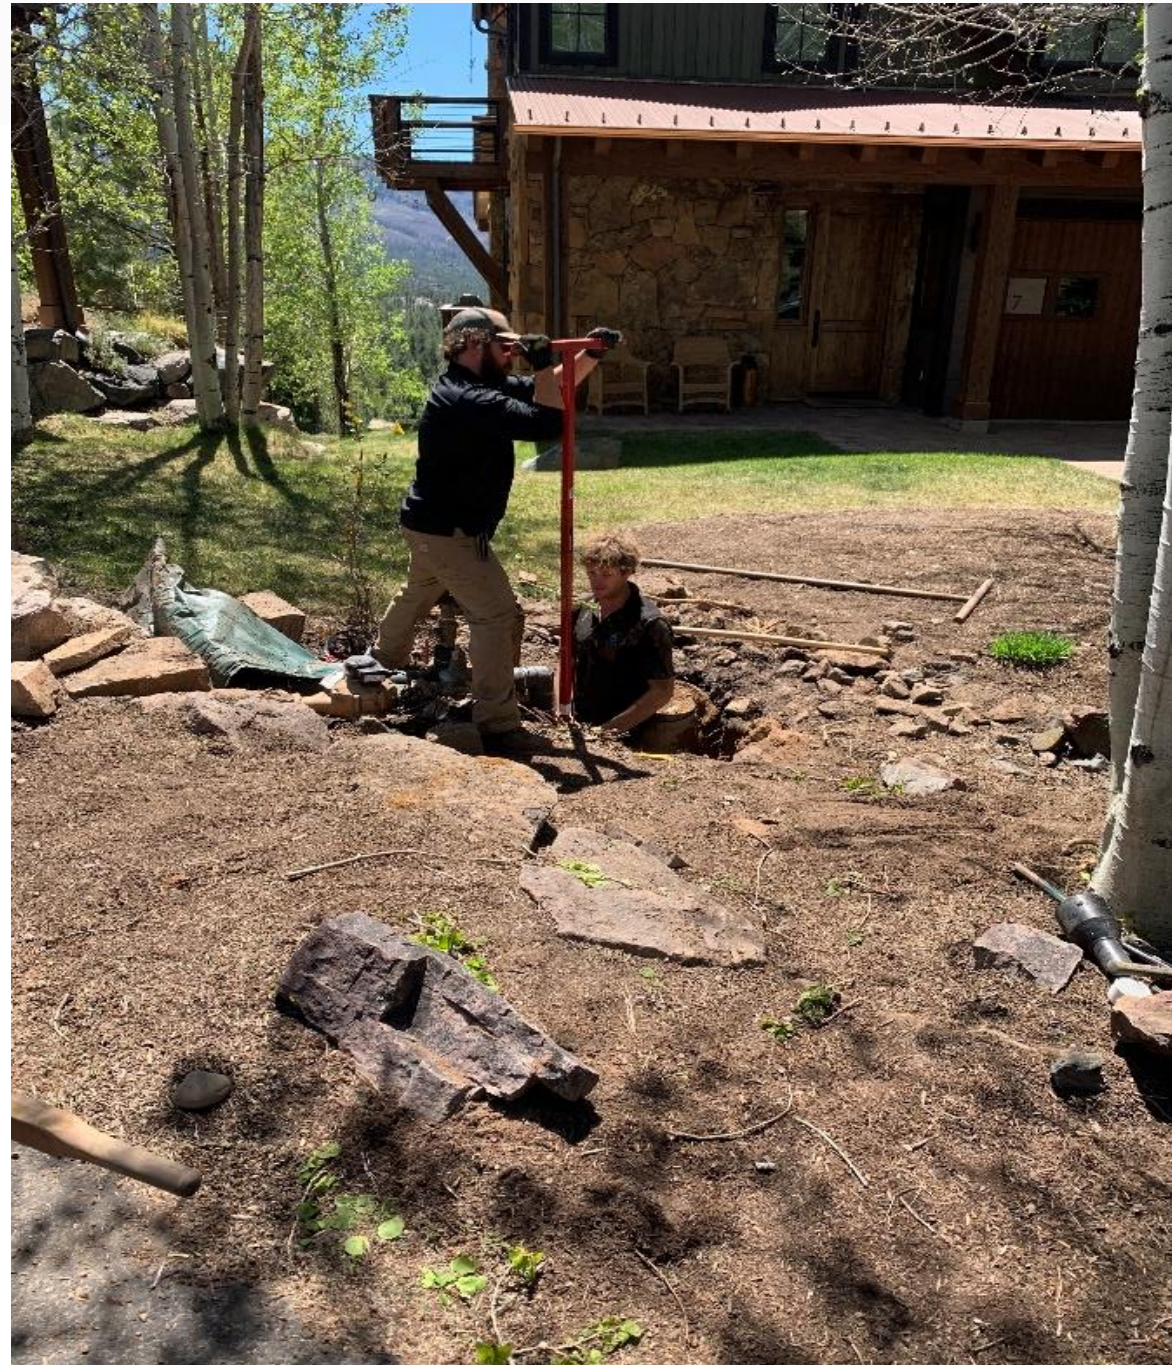
Now that irrigation season is here, we have been addressing irrigation service issues for the Landscaping Department. In this picture Alex and Logan work on an irrigation shutoff that had shifted so far off that the shutoff keys would no longer work. This is a common problem that occurs over time. I am extremely proud of these two. The energy they bring to the job, the willingness to learn and apply knowledge to the tasks they encounter is second to none!
